FLOATING OFFSHORE WIND  
CENTRE OF EXCELLENCE

# MOORING LINE AND DYNAMIC CABLE MONITORING AND REPLACEMENT METHODOLOGIES

Public Summary Report

Reference: PN000892-RPT-001

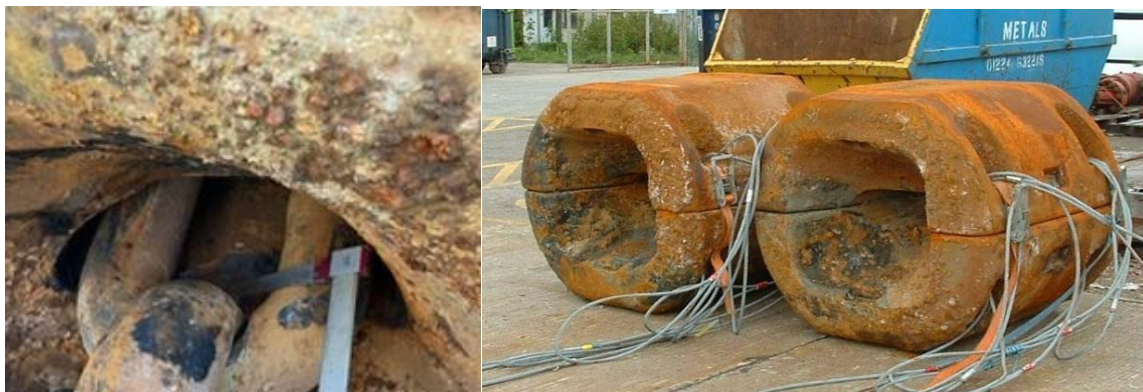
Figure 15 – High wear inside FPSO mooring clump weights and recovered clump weights from 2006 HSE RR444 report

The point below highlights where learning from O&G to floating wind could be improved. In this case the same clump weight design known to cause integrity issues are used decades on for floating wind mooring systems.

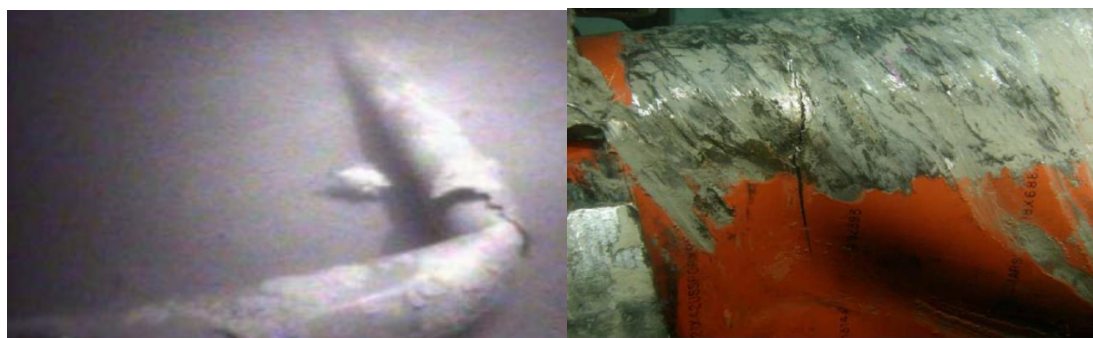
Figure 46 Kinked and cracked pipelines following Hurricane MODU run-over [25]
